Controls Southeast, Inc.

CSI Engineering Report: Analysis of Jumper Hose Leaks

Thomas Willingham
20 August 2009

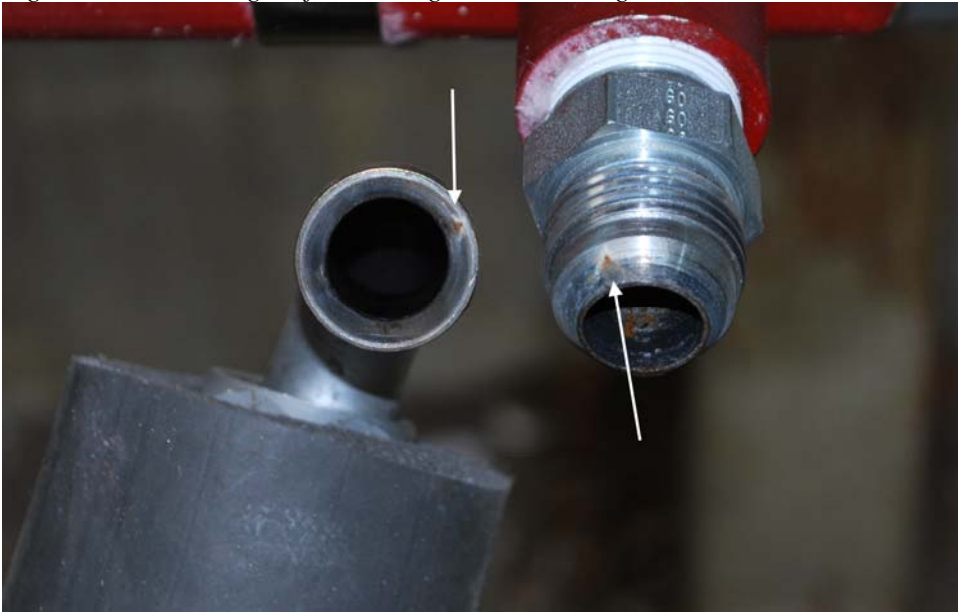
3. Leaks tend to worsen over time. Figure 3 shows the leak damage caused by inadequate torque during the 12-hour test. It can be seen that the leaking steam created erosion of the sealing surface. Depending upon how long the leaking has persisted, additional torque may be sufficient to stop the leaking. However, if the erosion is significant enough, even over-tightening beyond minimum torque may not be adequate to prevent stop leaking from a damaged JIC surface.

Figure 3: JIC sealing surface damage caused during 12-hour leak test.

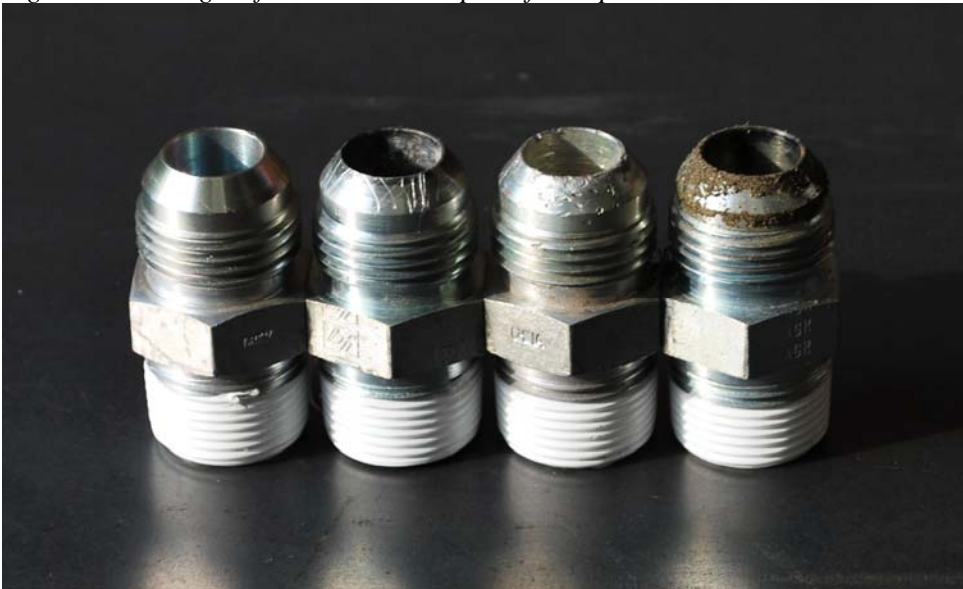
4. Extremely damaged surfaces can be sealed using a JIC repair gasket. A range of JIC surface degradation was tested, as shown in Figure 4. The JIC repair gasket (shown in Figure 5) was effective in eliminating leaks for all surfaces. This implies that failed JIC surfaces in the field can be addressed via replacing the adapter or applying a JIC repair gasket. It should be noted that the repair gasket is a one-time use gasket and would need to be replaced if the hose was disconnected.

Figure 4: Damage inflicted to JIC adapters for Expts 10-11.

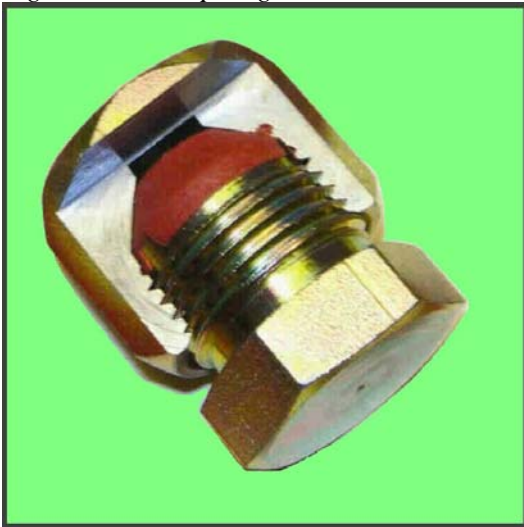
Figure 5: JIC repair gasket.

Jumper hose leaks due to hose weld and/or tubing failure cannot be field repaired and must be replaced. Leaks due to poor JIC connection and/or JIC surface damage may be addressed via replacing the JIC adapter or using a JIC repair gasket.
