**Controls Southeast, Inc.**

## CSI Engineering Report: Analysis of Jumper Hose Leaks

Thomas Willingham  
20 August 2009

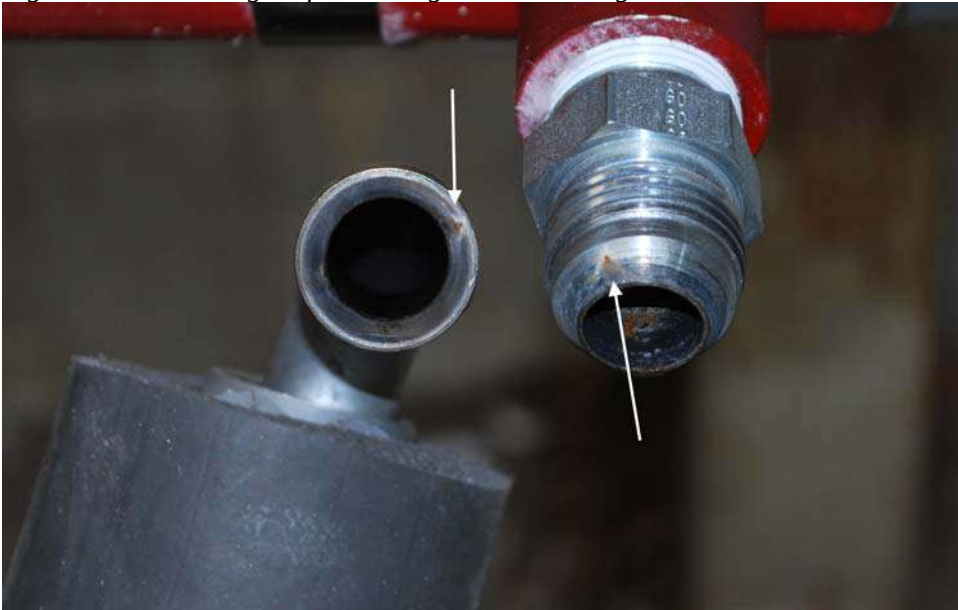
3. Leaks tend to worsen over time. Figure 3 shows the leak damage caused by inadequate torque during the 12-hour test. It can be seen that the leaking steam created erosion of the sealing surface. Depending upon how long the leaking has persisted, additional torque may be sufficient to stop the leaking. However, if the erosion is significant enough, even over-tightening beyond minimum torque may not be adequate to prevent stop leaking from a damaged JIC surface.

*Figure 3: JIC sealing surface damage caused during 12-hour leak test.*

1. Verify the mating threads are clean of dirt/debris.
2. Verify the JIC sealing surfaces are clean of dirt/debris and damage.
3. Install jumper hose without subjecting the hose to torsion, overbending, or compression.
4. Tighten the connection to industry-recommended minimum torque values.

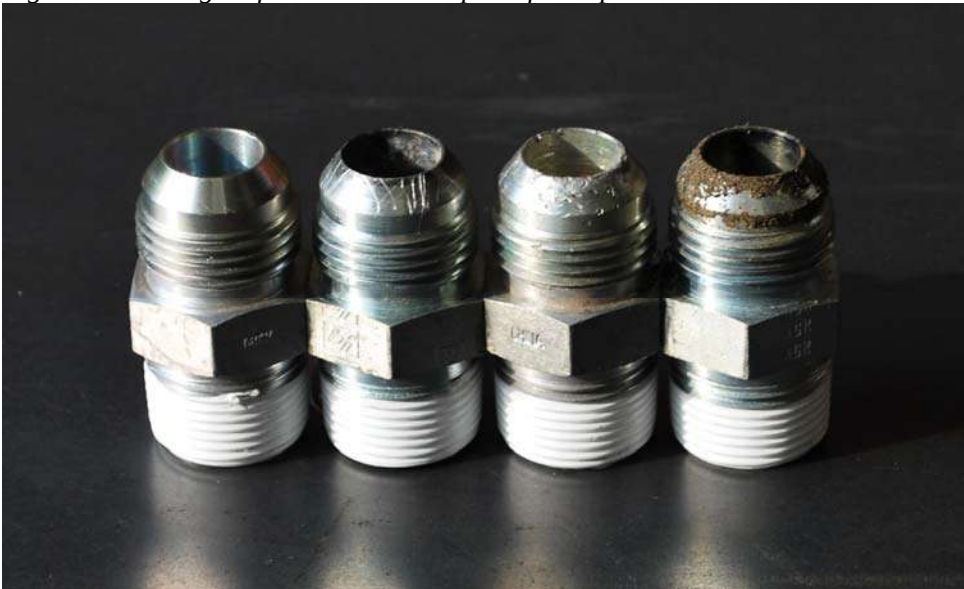
4. Extremely damaged surfaces can be sealed using a JIC repair gasket. A range of JIC surface degradation was tested, as shown in Figure 4. The JIC repair gasket (shown in Figure 5) was effective in eliminating leaks for all surfaces. This implies that failed JIC surfaces in the field can be addressed via replacing the adapter or applying a JIC repair gasket. It should be noted that the repair gasket is a one-time use gasket and would need to be replaced if the hose was disconnected.

*Figure 4: Damage inflicted to JIC adapters for Expts 10-11.*

Jumper hose leaks due to hose weld and/or tubing failure cannot be field repaired and must be replaced. Leaks due to poor JIC connection and/or JIC surface damage may be addressed via replacing the JIC adapter or using a JIC repair gasket.

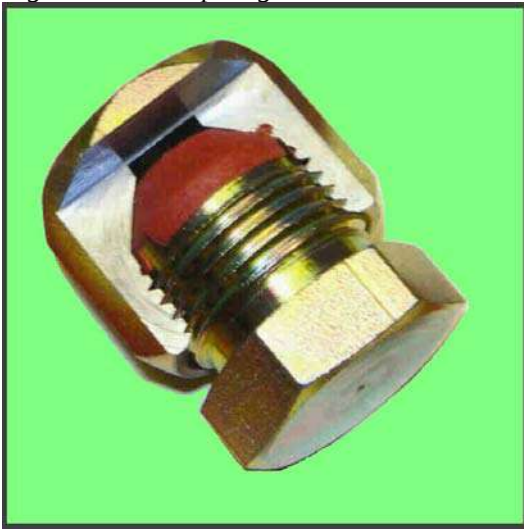
*Figure 5: JIC repair gasket.*
