Stop quenching those sulphur vapour lines

In sulphur recovery units the treated tail gas, tail gas bypass and sweep air lines are normally routed to the incinerator. **T.C. Willingham** of Controls Southeast, Inc. explores several of the common pipe routings that result in corrosive conditions that can lead to line failures. Specific problems associated with these common pipe routings, as reported from the field, are examined. Several recommendations and industry best practices for preventing or minimising similar line failures are provided.

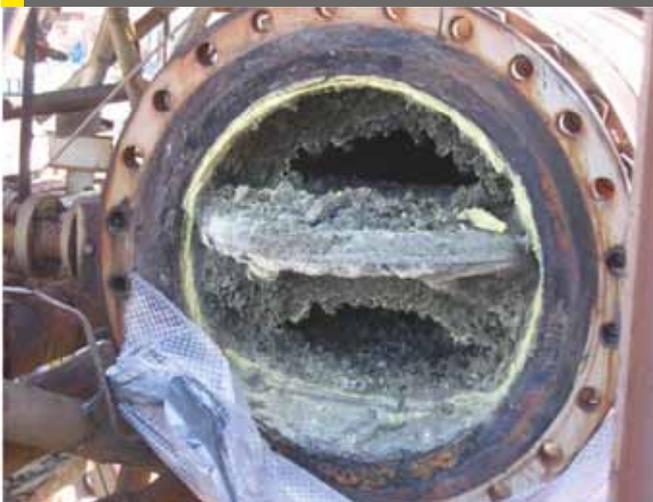
Fig 1: Tail gas line failure due to plugged diverter valve

process streams with very different temperature requirements. The higher volume of low-temperature treated tail gas has the effect of quenching the lower-volume sulphur vapour. Upon quenching, the sulphur solidifies and tends to plate out on the inside of the treated tail gas line. Furthermore, due to the low temperature of the quenched stream and the presence of water vapour in the stream, conditions are set for an aggressive corrosion condition. Such conditions can quickly lead to line failures such as those shown in [Figs 1 and 2](#).

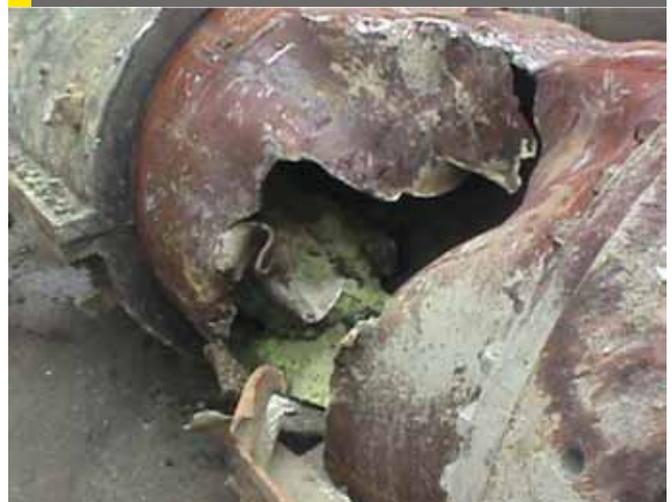
Fig 2: Tail gas line failure due to extreme corrosion
